Manhole Inspection Summary

Manhole # S19GG2026MH

Location Address: **5910 FALLS RD** Cross Street: **WASHINGTONVILLE**

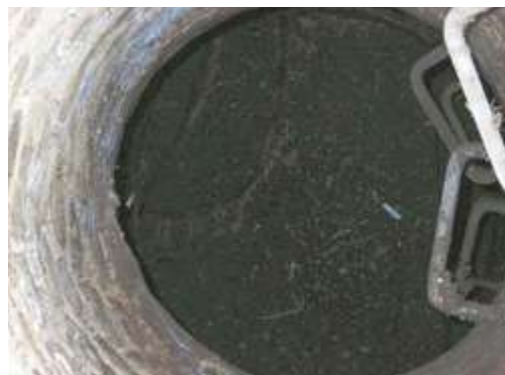
Top View

Bench and Channel debris.

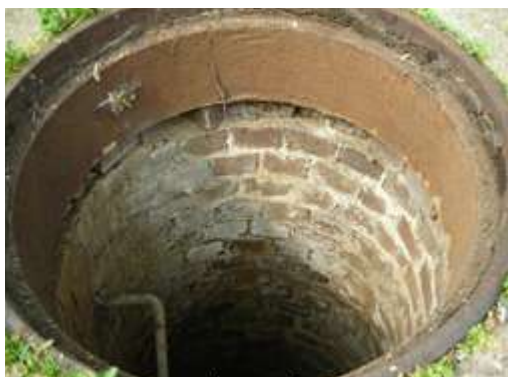
Defect

Frame leaks. Adjustment deterioration, loose brick and infiltration. Corbel and Barrel infiltration

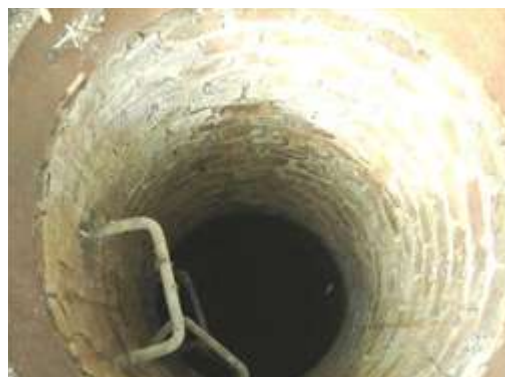
Defect

Frame leaks. Adjustment deterioration, loose brick and infiltration. Corbel and Barrel infiltration

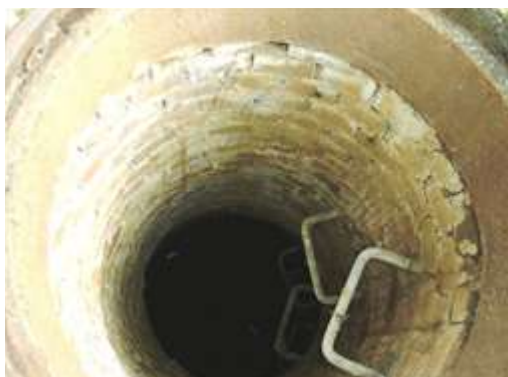
Defect

Frame leaks. Adjustment deterioration, loose brick and infiltration. Corbel and Barrel infiltration - other side.

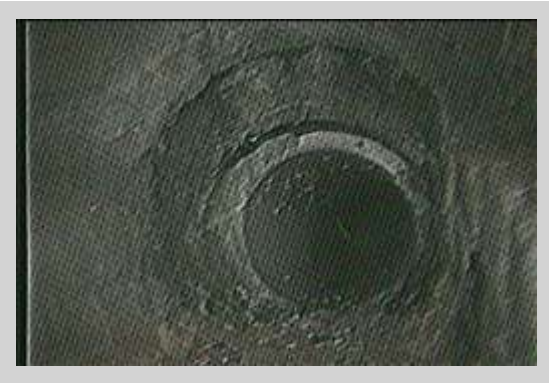
12 in. Circular Gravity Sewer Pipe Out @ 12 O'Clock

Barrel deterioration and infiltration. Channel deterioration.

Deposits: ☐ None ☒ **Mud** ☐ Sludge ☒ **Debris** ☐ Grease

Silt Depth: **0.5** (in.) Deposits Extent: **Light**

Infiltration: **Evidence** Pipe Seal Cond: **Unknown**

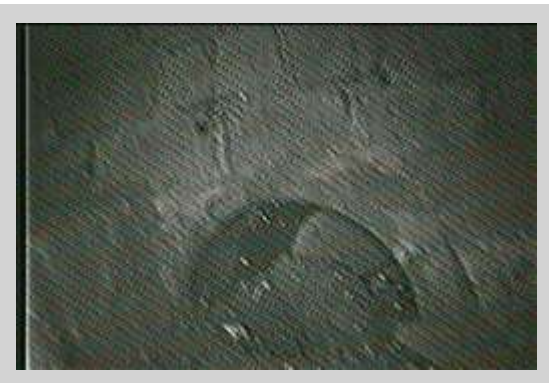
8 in. Circular Gravity Sewer Pipe In @ 8 O'Clock

Infiltration: **Evidence** Pipe Seal Cond: **Unknown**

Connects To: **Stub connection / abandoned**
